# **Road Safety Study – Candia Road**

## **‘Before’ and ‘After’ Crash Study**

Bruno Royce - BScEng (Civil)(Hons) MBA CPEng IntPE MIPENZ APEC Engineer

Traffic Engineering Solutions, PO Box 7237, Auckland 1010

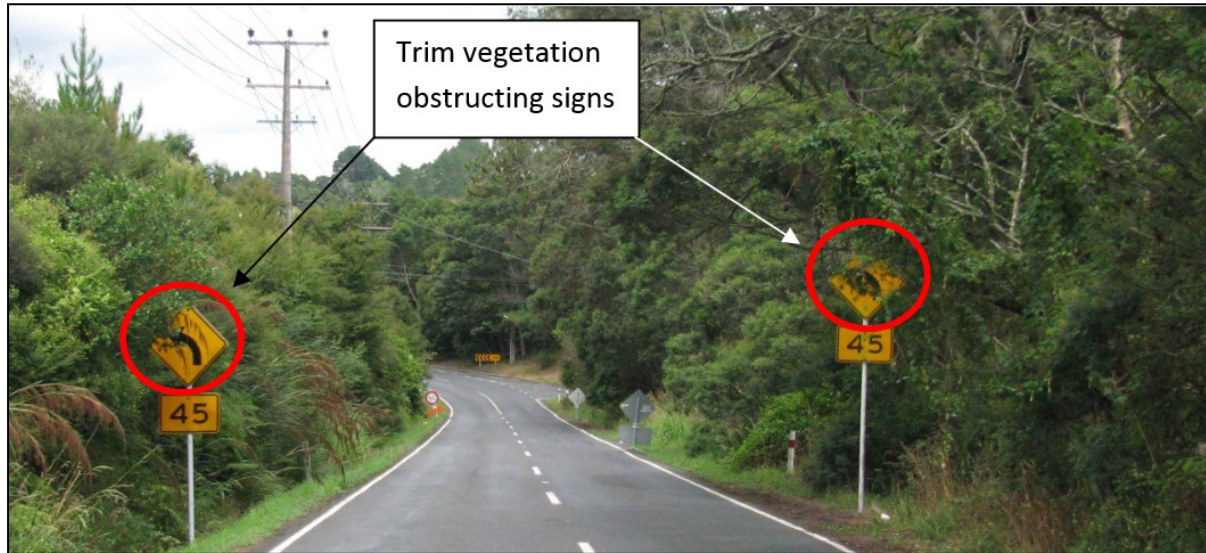
- Excessive vehicle speeds for the road environment, with two relatively sharp bends and one moderate bend on a road with a posted speed of 70km/h;
- Lack of conspicuity of curve warning signage, with the existing curve warning signage being technically correct but limited in terms of visibility (number, location, size, and obstructed by vegetation);
- Narrow and unforgiving road shoulders, reducing the space available for motorists to correct an errant vehicle;
- Ineffective road-marking delineation (faded edgeline and centreline);
- Irregular road surface condition (patch seal repairs and evidence of seal failure);
- Inconsistent super-elevation (undulating road surface);
- Insufficient road surface skid resistance (visual evidence of longitudinal cracking and flushing of seal surface).

**Figure 2: Visibility of Advance Warning signs obstructed by vegetation (view southwards towards Vineyard Road)**

- **Edge marker posts:** Maintain posts and install additional posts, for improved delineation, particularly at night;
- **Vegetation trimming:** To improve forward visibility of existing and proposed signage;

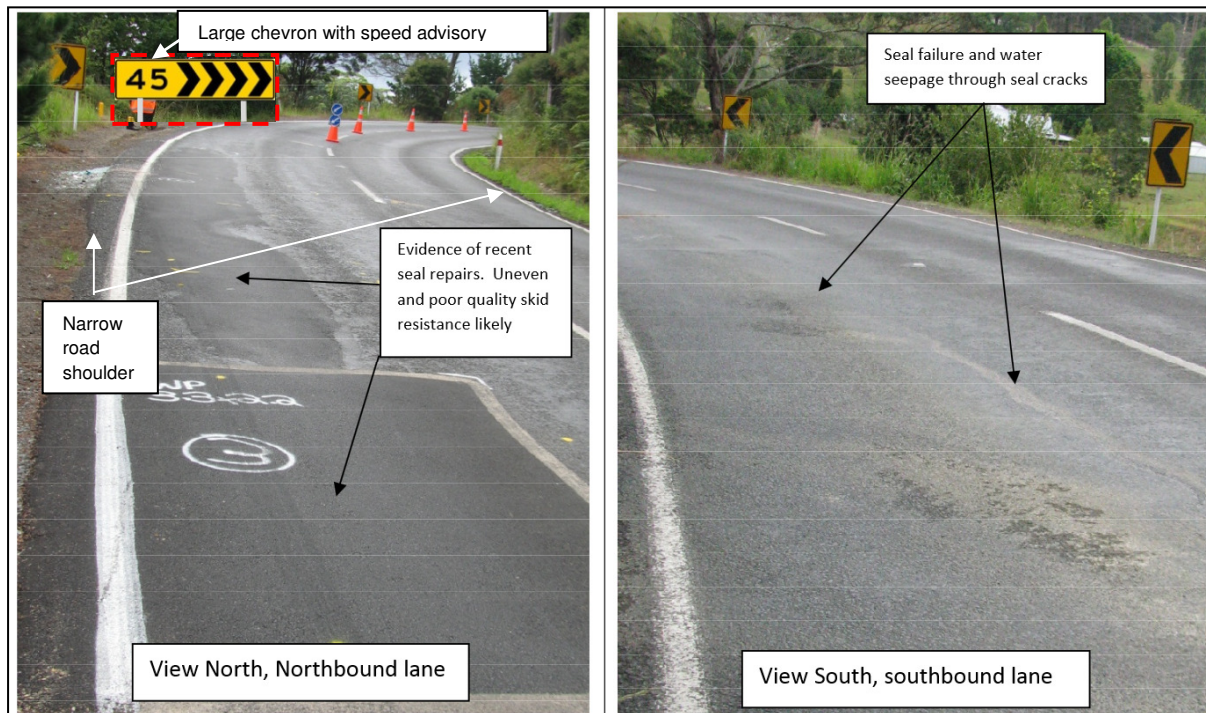
**Figure 3: Signage and Road surface issues at the bend north of Vineyard Road**

- **Curve warning signage and chevrons:** Upgrade quantity, size, visibility and double-gate;
- **Embankment:** Cut-back embankment to improve forward visibility on the inside of one bend;

- **Shape correction:** To provide a smooth road surface and consistent super-elevation around the bends;
- **Skid resistant surface:** A highly skid-resistant road surface (Polished Stone Value > 70) at two bends, reducing likelihood of loss-of-control at the bends;

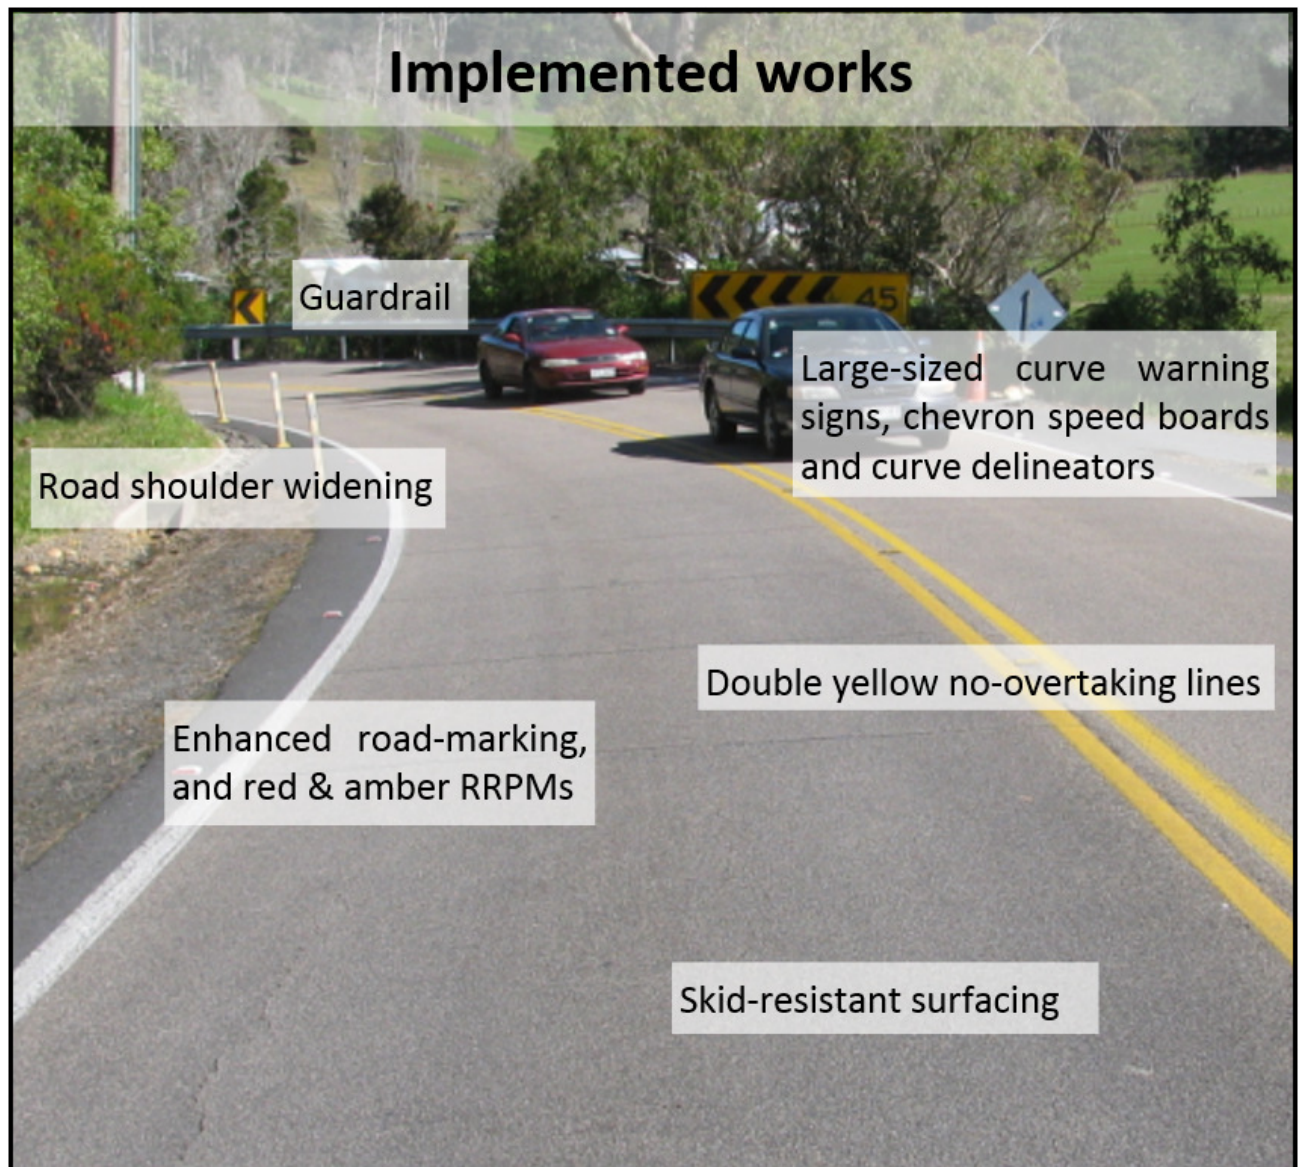
**Figure 4: Constructed works on the northern approach to the bend north of Vineyard Road. Similar works were implemented on the southern approach to this bend.**

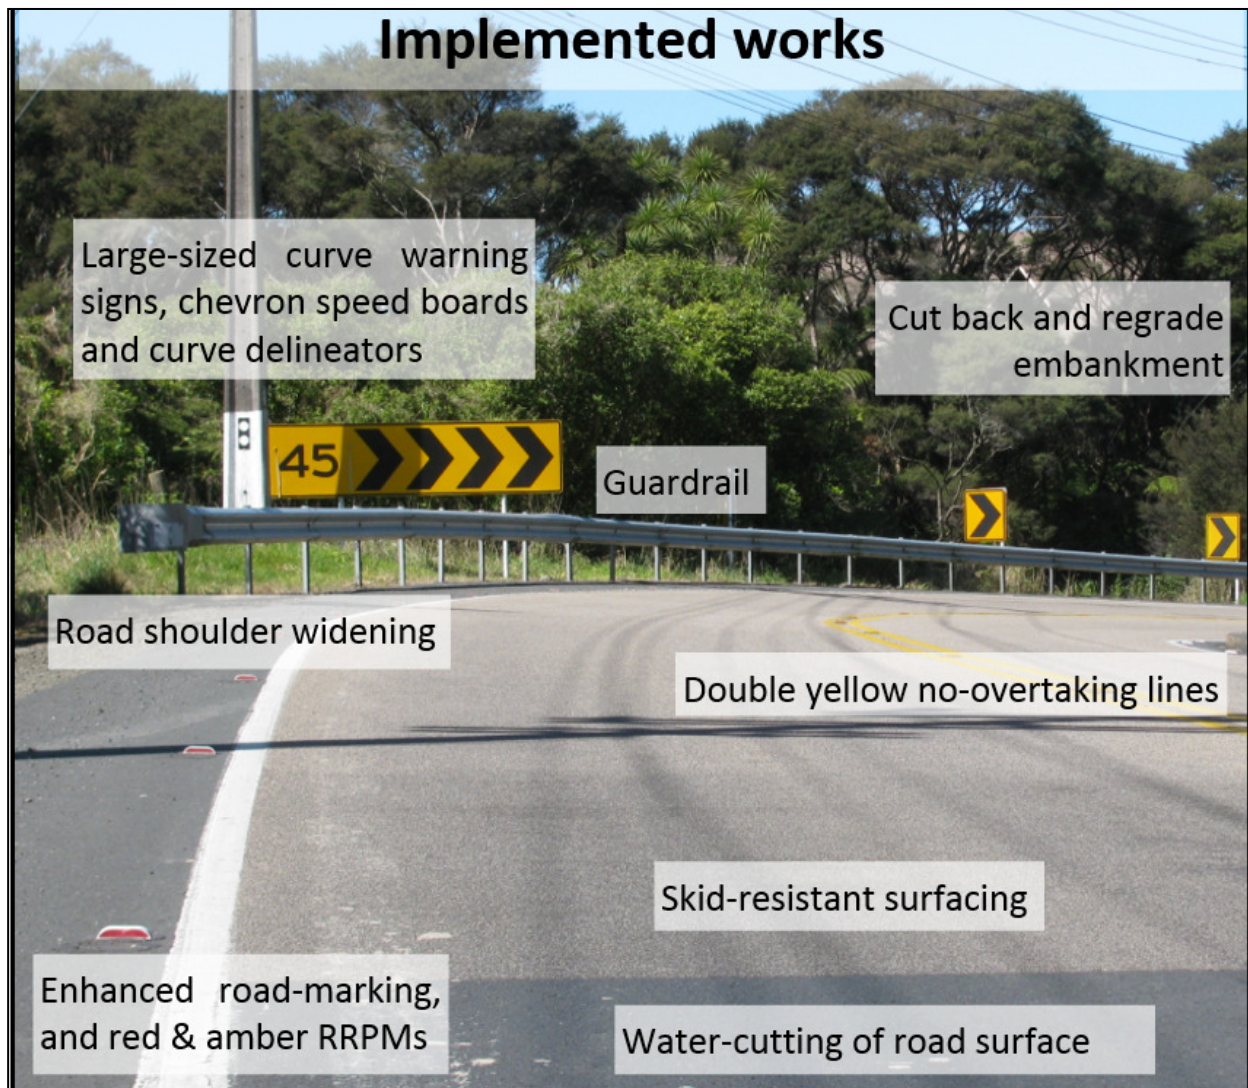
**Figure 5: Constructed works on the northern approach to the bend south of Vineyard Road. Similar works were implemented on the southern approach to this bend.**

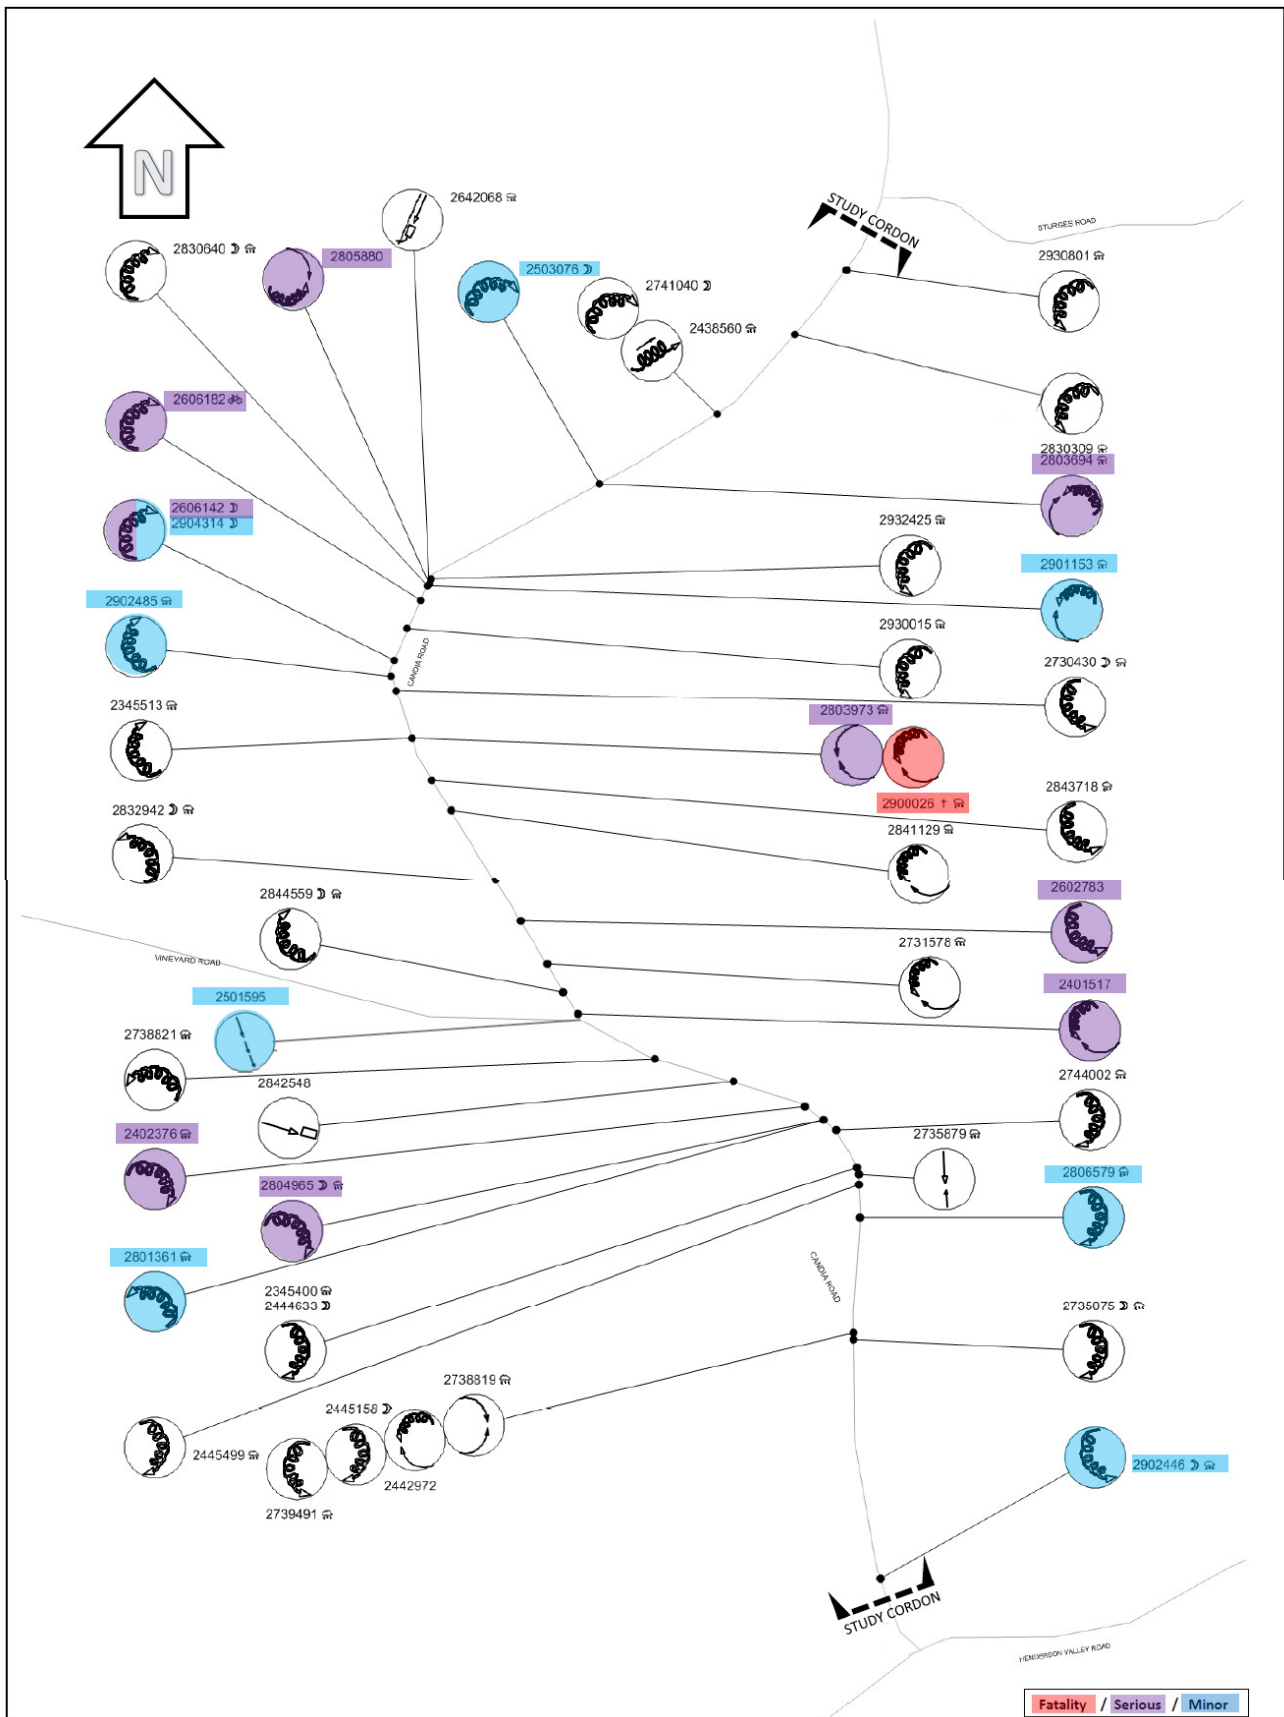
Figure 6 illustrates a CAS plot of reported crash statistics 'before' the crash remedial measures were installed. The position of most crashes has not been edited, and the crashes appear to be distributed along the entire route.

Figure 6: NZTA CAS Plot: Candia Road – All Reported Crashes 2003 – 2009. In total, 45 reported crashes over seven years, including 1 fatality, 9 serious injury, and 8 minor injury crashes. Crashes plotted along the route, similar to the original CAS plot.

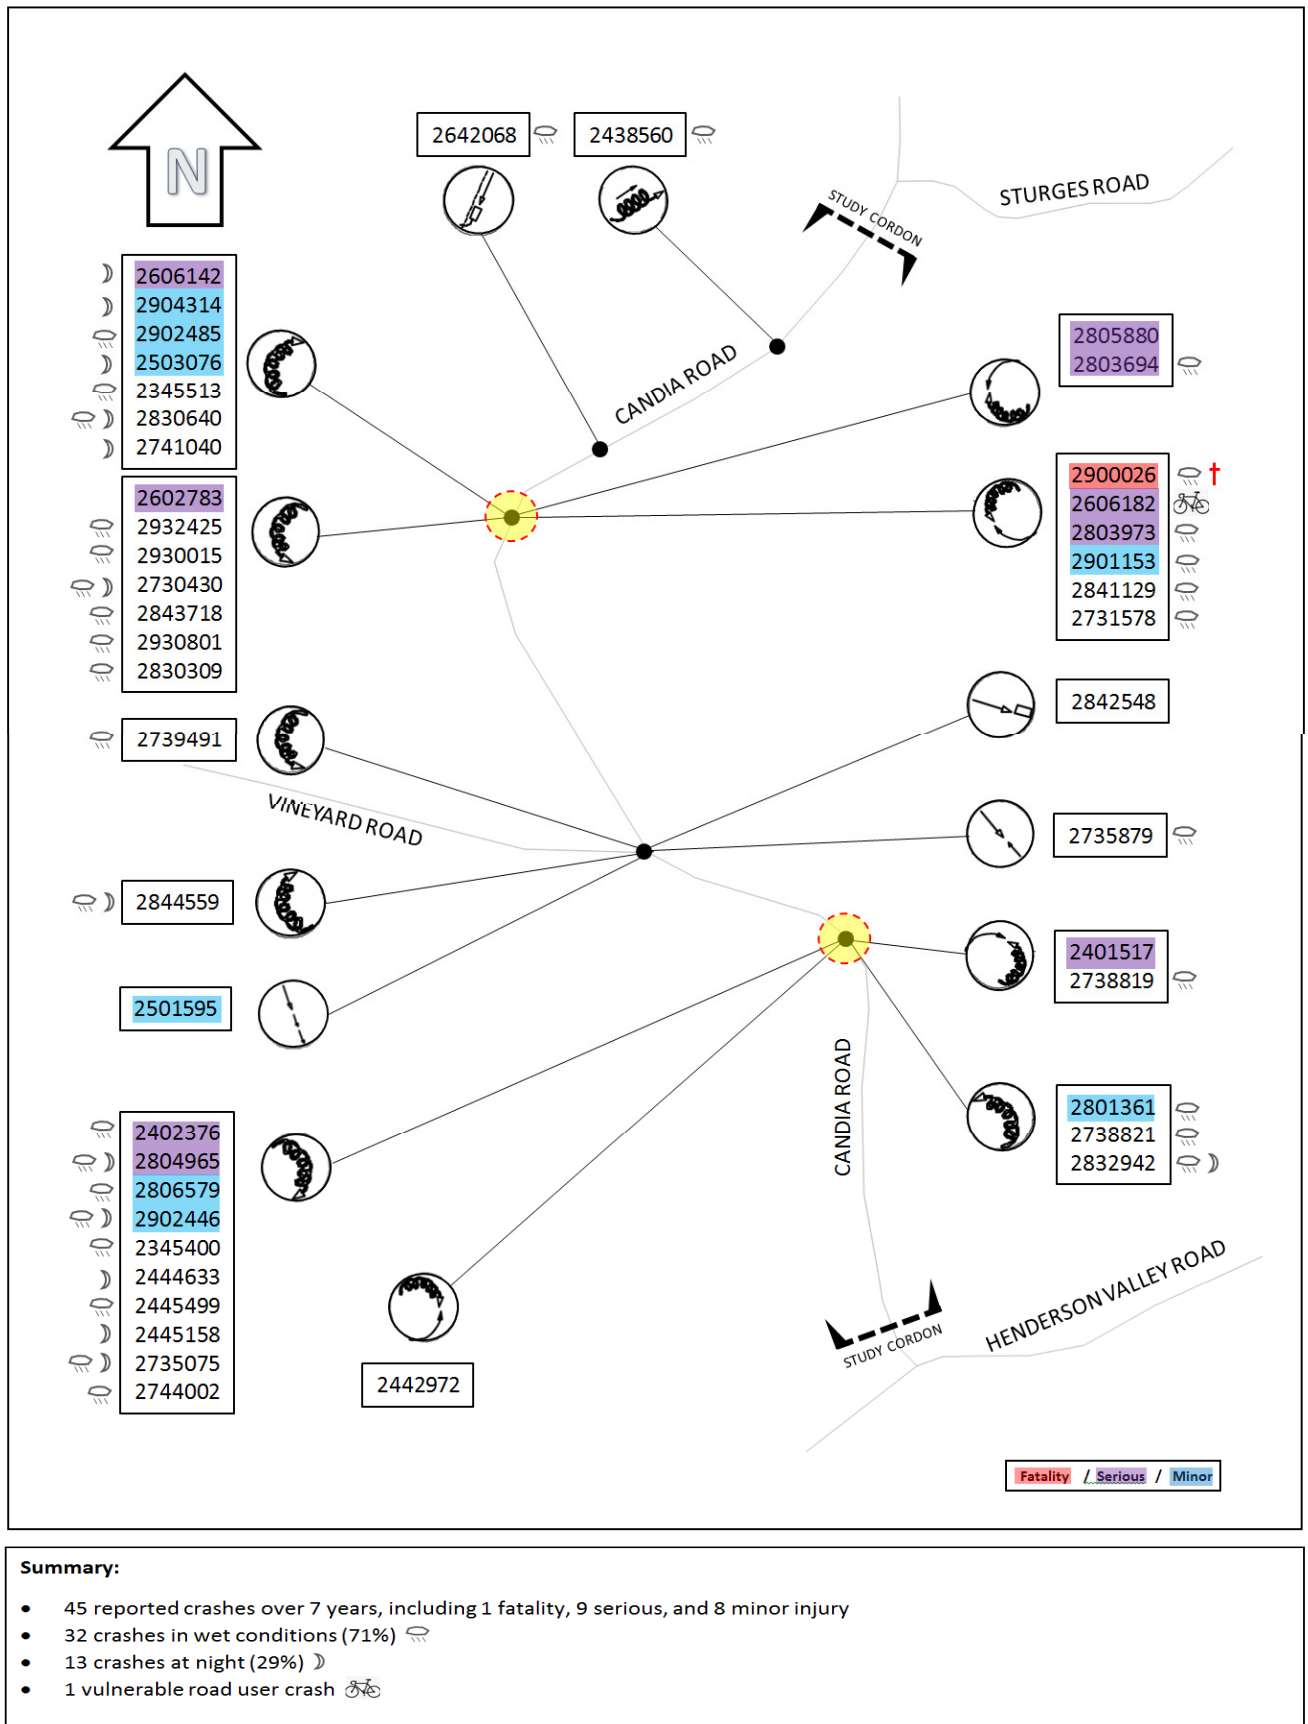
Figure 7 illustrates the same crashes as Figure 6, but Traffic Crash Reports have been analysed in detail and the exact nature, position and direction of each crash re-plotted. Correct interpretation of Traffic Crash Reports can require significant experience and technical expertise. This further analysis results in crash patterns being much stronger and more evident. This enables the causal factors to be identified more accurately, and any proposed remedial works to be focussed on the main issues.

**Figure 7: NZTA CAS Plot: Candia Road – All Reported Crashes 2003 – 2009.** In total, 45 reported crashes over seven years, including 1 fatality, 9 serious injury, and 8 minor injury crashes. Traffic Crash Reports analysed and crashes re-plotted and grouped accurately.

- The key causal factors relating to the crash patterns (excessive speed and loss of control at the two main bends) were precisely identified by reading all the available Traffic Crash Reports, with most of the reported crashes re-positioned and re-plotted (Figure 7). The initial crash plot (Figure 6) indicated crashes distributed relatively evenly along the route, which was misleading, and necessitated preparation of Figure 7. Also, non-injury crashes were considered important to help identify crash patterns/locations;

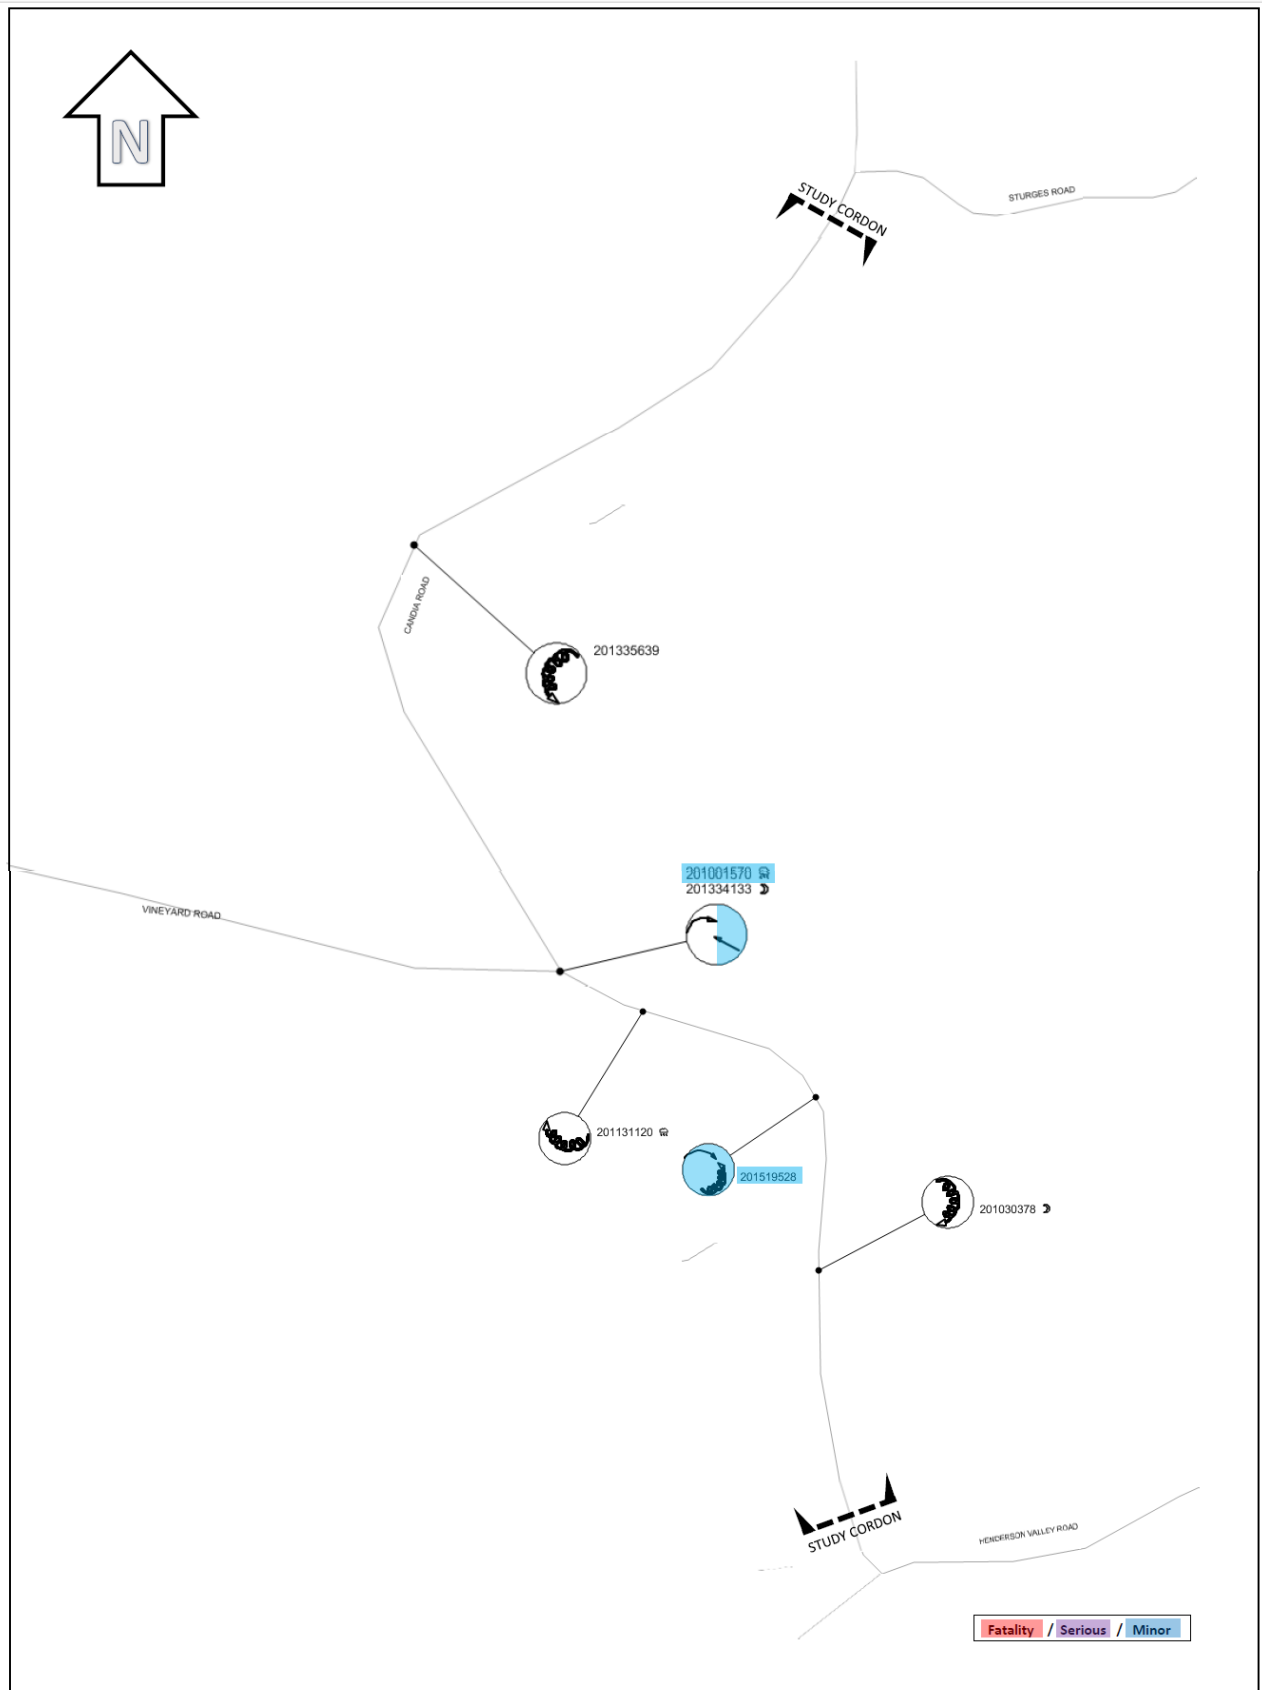
Figure 8 illustrates a CAS plot of reported crash statistics 'after' the crash remedial measures were installed. In this case the Traffic Crash Reports were not analysed for accuracy of the crashes' positions and directions, as it is evident that there have been significant crash savings achieved, and the exact nature of the crash patterns are less relevant at this stage of the analysis.

**Figure 8: NZTA CAS Plot: Candia Road – All Reported Crashes 2010 – 2016. In total, 6 reported crashes over seven years, including 2 minor injury crashes. These crashes are in the locations provided by the Crash Analysis System.**

- From 2003 to 2009, 45 crashes were reported within the study cordon. Only 6 crashes were reported from 2010 to 2016. Thus, reported crashes along the study cordon have reduced 87%. This result achieves statistical chi-squared significance greater than 99.9%. Also, over the intervening time periods, traffic volumes on Candia Road were estimated to have increased by around 40%;
